Technical Article: Written by Scott Worthington.

### External Efflorescence?

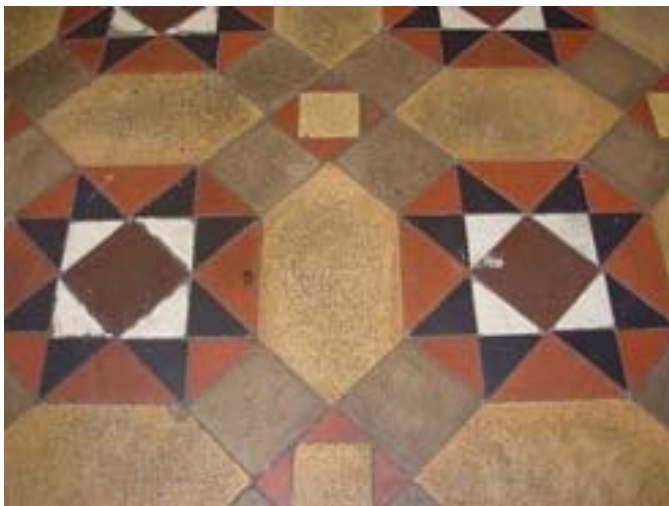
Before

Just thought you might like to see these photos, it's the first time I've gone to Ex-Treme due to the level of in ground dirt. They don't really do justice to how the filthy the tiles were, or how clean they now look, but it's an interesting comparison.

This 100 year old floor was so filthy with in ground dirt and wear that the customer had considered screeding over it and carpeting. It had been a student rental property for the previous 20 years, and had been seriously neglected. So on this floor I used a combination of Ex-Treme and Nano-Scrub with a low rpm scrubbing machine. The Ex-Treme was used in a 1:1 ratio with water and given 20 minutes dwell time. NanoScrub was then added and the floor was scrubbed. Once rinsed down thoroughly it was left to dry for a day and then treated with Eff-Ex to remove some efflorescence that developed. These pictures were taken once sealed with Seal and Finish Low Sheen (but prior to being treated with Floor Shine and Hardener).
